Pneumatic Troubleshooting

In this walkthrough we will address a couple different issues, all pertaining to a pneumatic error.

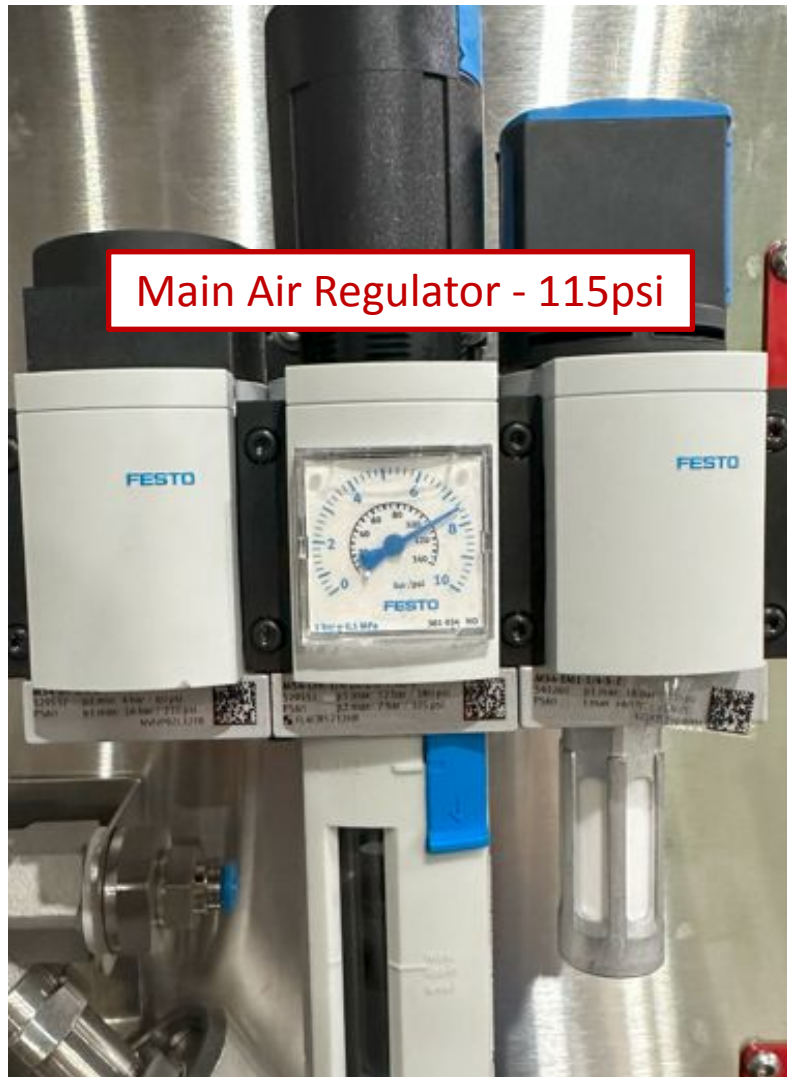
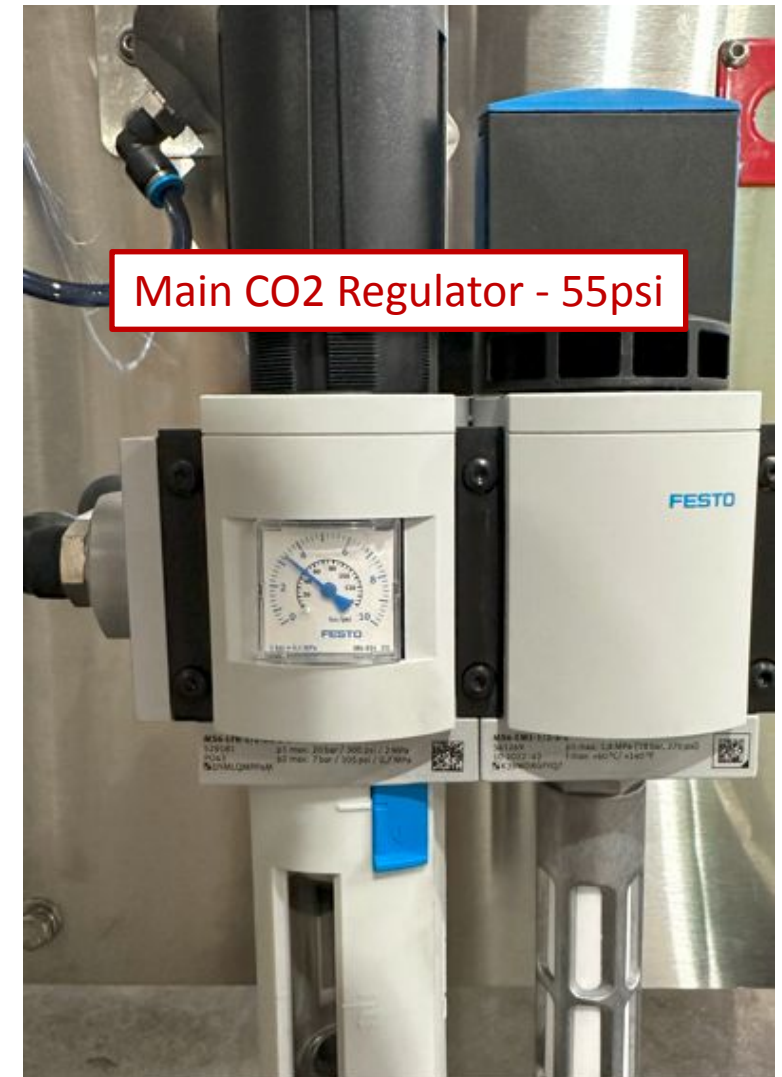
After confirming flow from compressor/CO2 tank to the filler, verify that the regulators on the Codi filler are showing a value, and the air/CO2 are making it to the machine.

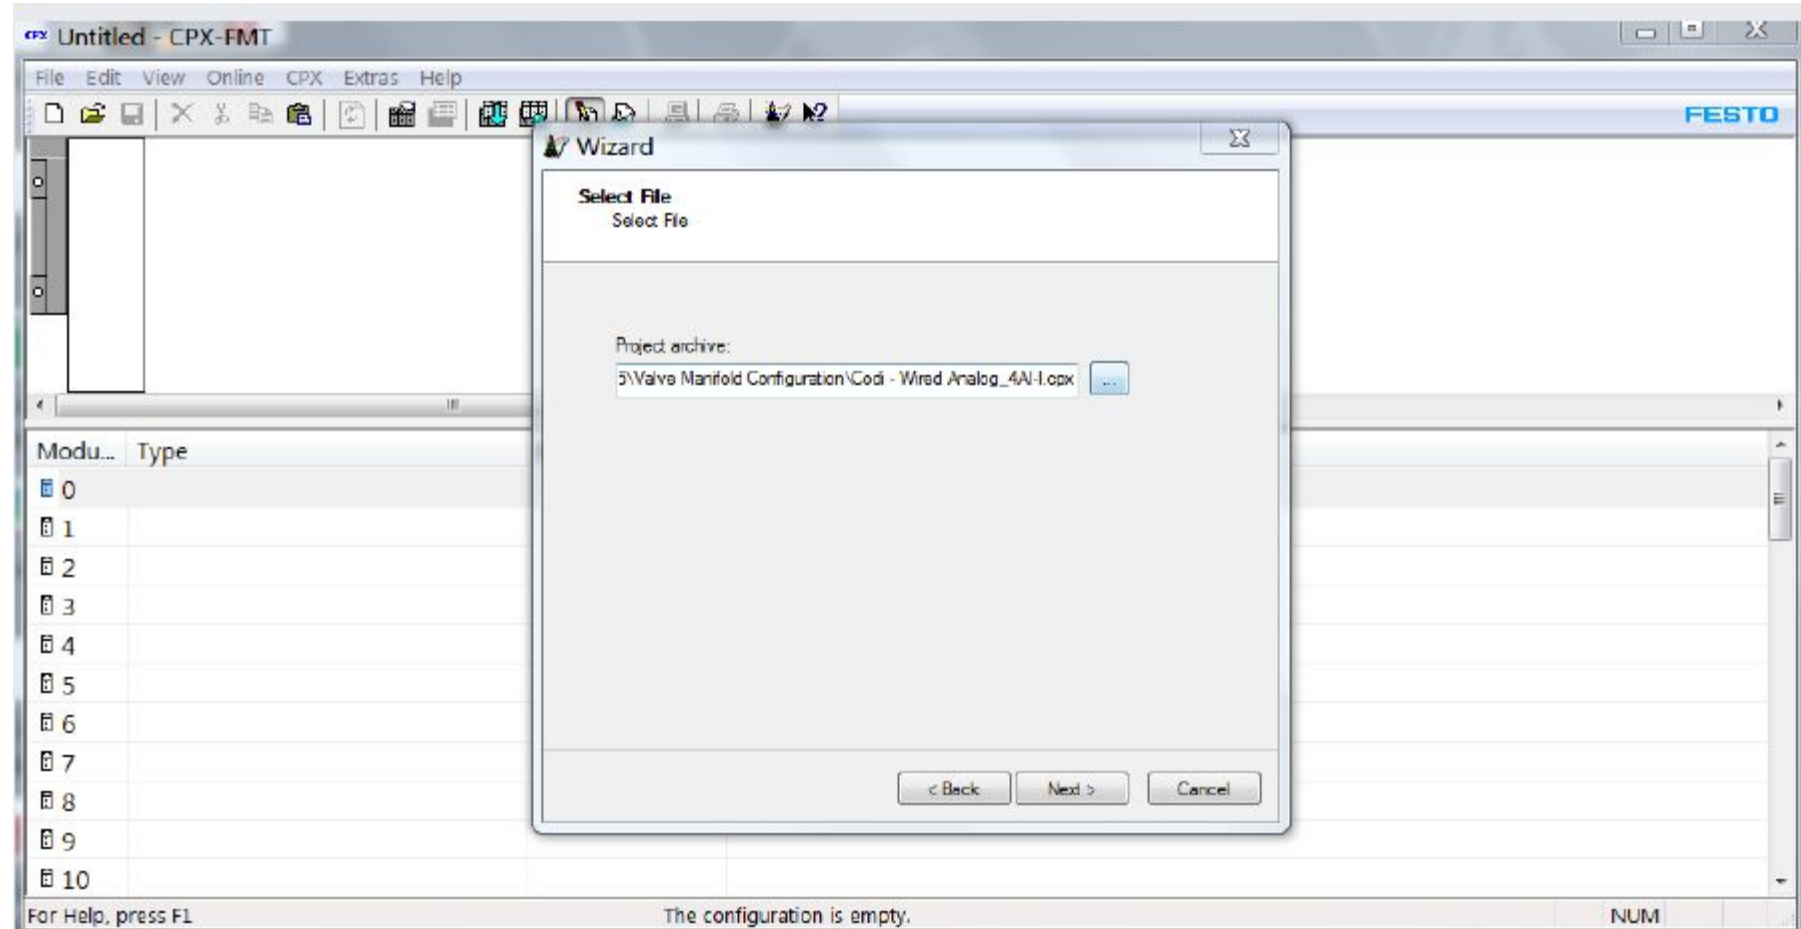
After the program has opened, it will look like this. Click the next button to begin operation of the maintenance tool.

The next screen shows the file being uploaded to the valve manifold. If you need to browse and locate it, it will be a .cpx file extension.

There will be a couple different prompts where you will hit the next button till you get to this screen.

Ensure that the IP Address in the window is exactly as you see here.

If you see any face other than a normal smiley face, exit out and start the process over again. If this issue persists, contact the Codi Service Team.

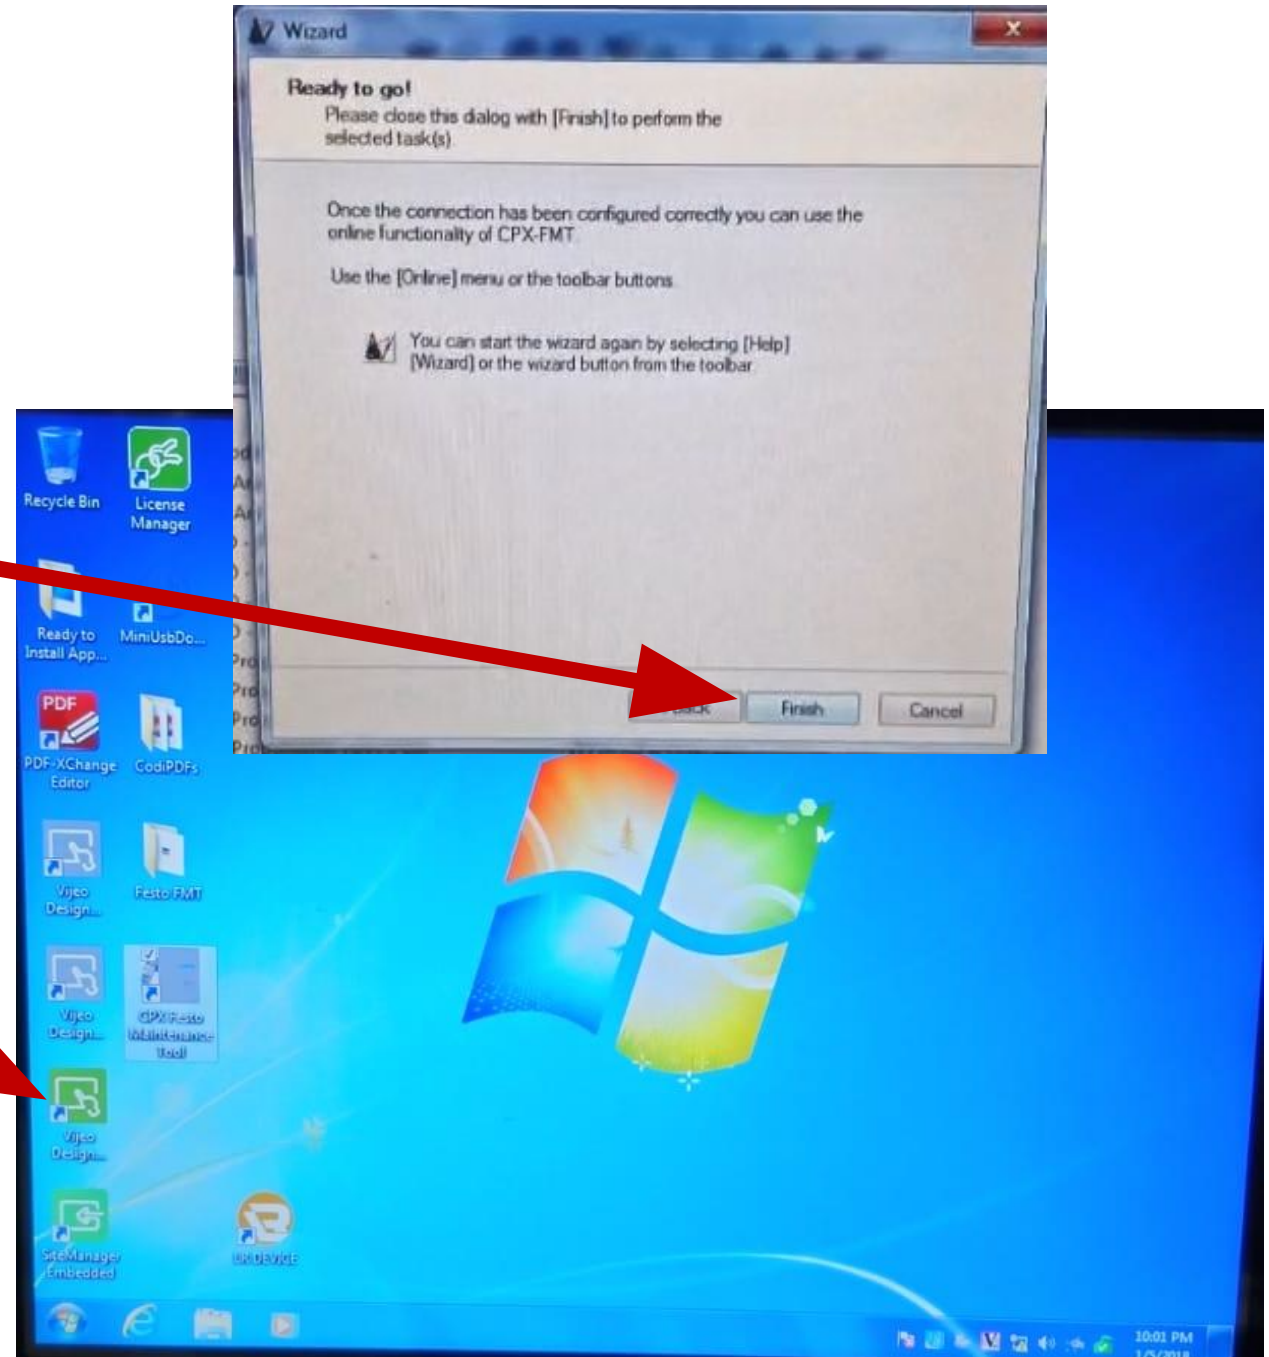
The issue we repaired was the Festo Valve Manifold had lost its values and they needed to be reloaded onto the unit from the PLC. This issue may happen twice in a week, once a year, or every power cycle, the fix is always the same.

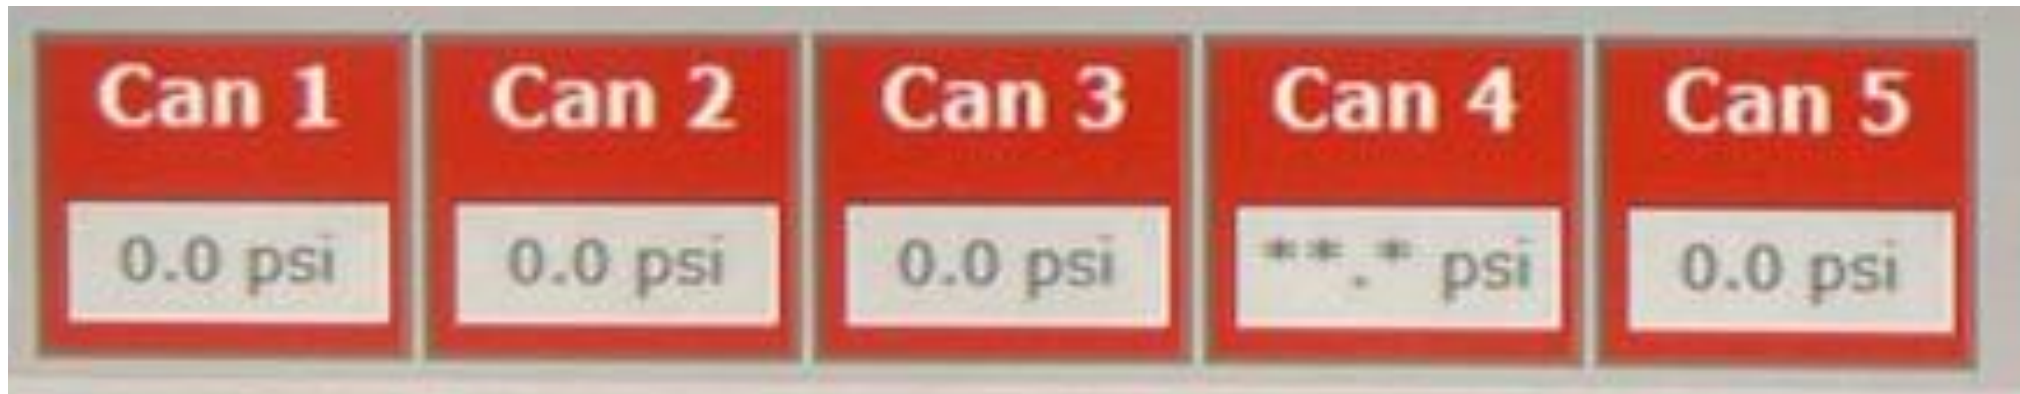
The screenshot displays a control panel for a filling machine. At the top left, a yellow box indicates 'FILLING PAUSED'. A blue 'RUN ONE CYCLE' button is visible. The 'TANK' section shows a temperature of 60 °F and two pressure gauges, both at 0.0 psi. The 'INLETS' section shows AIR at 80.1 psi and CO2 at 95.3 psi. The 'PURGE' section includes a 'Flush Timer (s)' set to 1.0 and 'Evacuate Cycles (n)' set to 2. The 'FILL' section shows 'Container Size' at 16.0 oz, 'Pressure Drop' at 4.0, 'Time (s)' at 8.6, and 'Throttle' at 6.0. The 'SNIFT 1' section shows 'Time (s)' at 0.8 and 'Choke Throttle' at 22. The 'SNIFT 2' section shows 'Time (s)' at 0.8 and 'Choke Throttle' at 5. The 'SPEEDS' section shows 'Conveyor (ft/min)' at 32, 'Screw Offset (ft/min)' at 5, and 'Seamer Offset (cans/min)' at 12. The 'Product Pump' section has 'AUTO' and 'STOPPED' buttons. A 'Cans/Min' section shows a rate of 35 and a 'LIMIT CPM OFF' button. At the bottom, a status bar for five cans shows: Can 1 (0.0 psi), Can 2 (0.0 psi), Can 3 (0.0 psi), Can 4 (**.*) psi, and Can 5 (0.0 psi). A red arrow points from the text box to the Can 4 status.

In the photo below we see that can 4 is not registering a value, this this issue could be caused by the transducer, the cable, the module block, or the connections at any of those points. We need to isolate the issue.

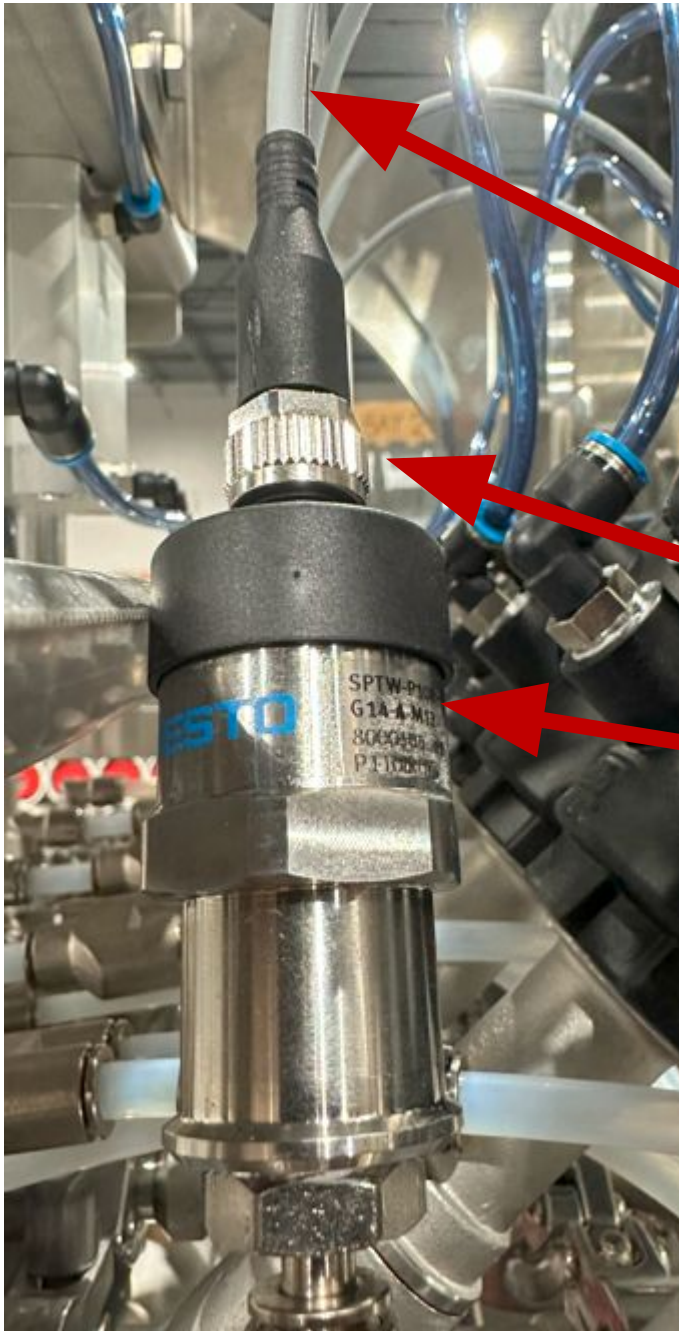
For potential causes of the **.*, we have a cable running from transducer to the Festo Manifold at the back of the machine.

We have the first connection point.

We have a transducer at that fill head plugged into the T quick connect for the choke throttle.

We have a connection point of the cable and module with 2 seated wires and a jumper inside the connector.

And finally we have the module itself.

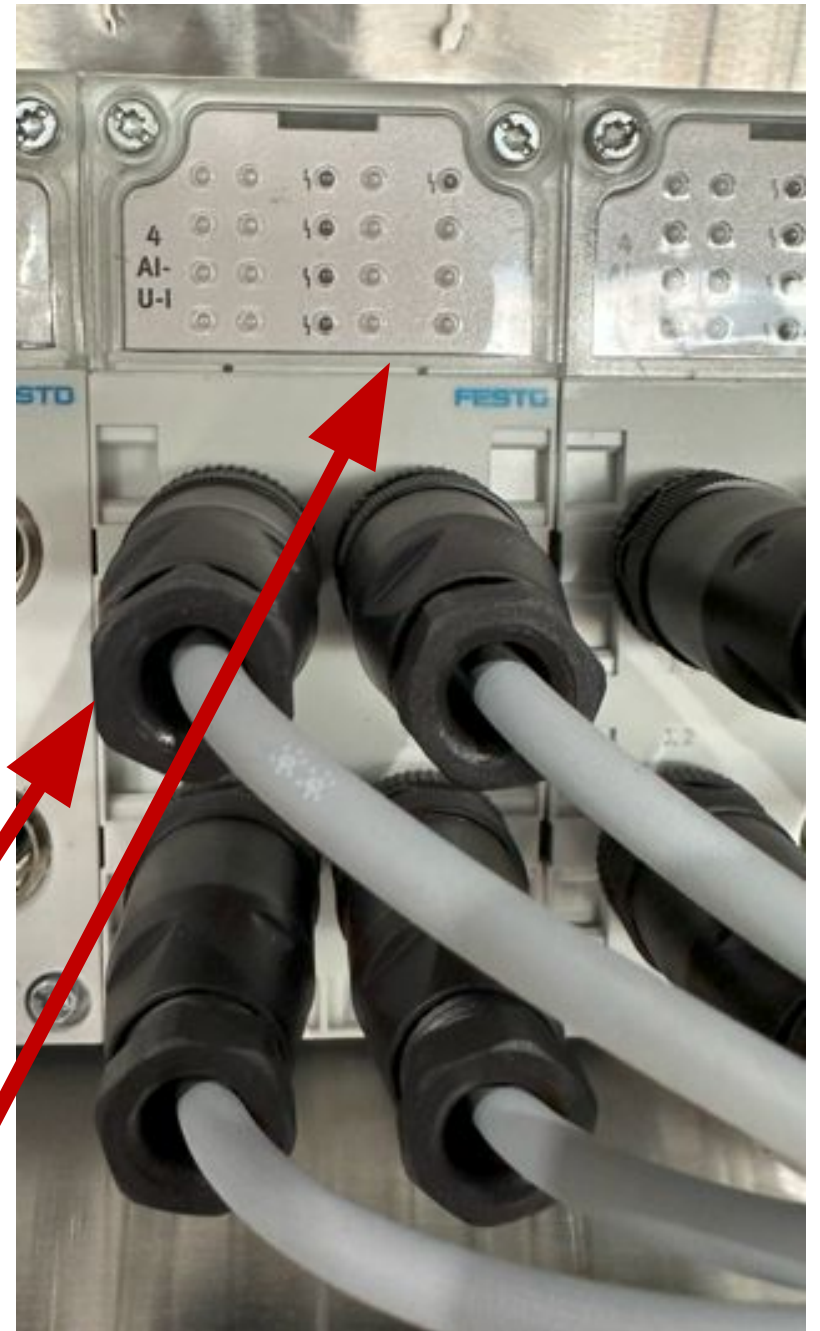
Disconnect here and the quick connect to swap over.

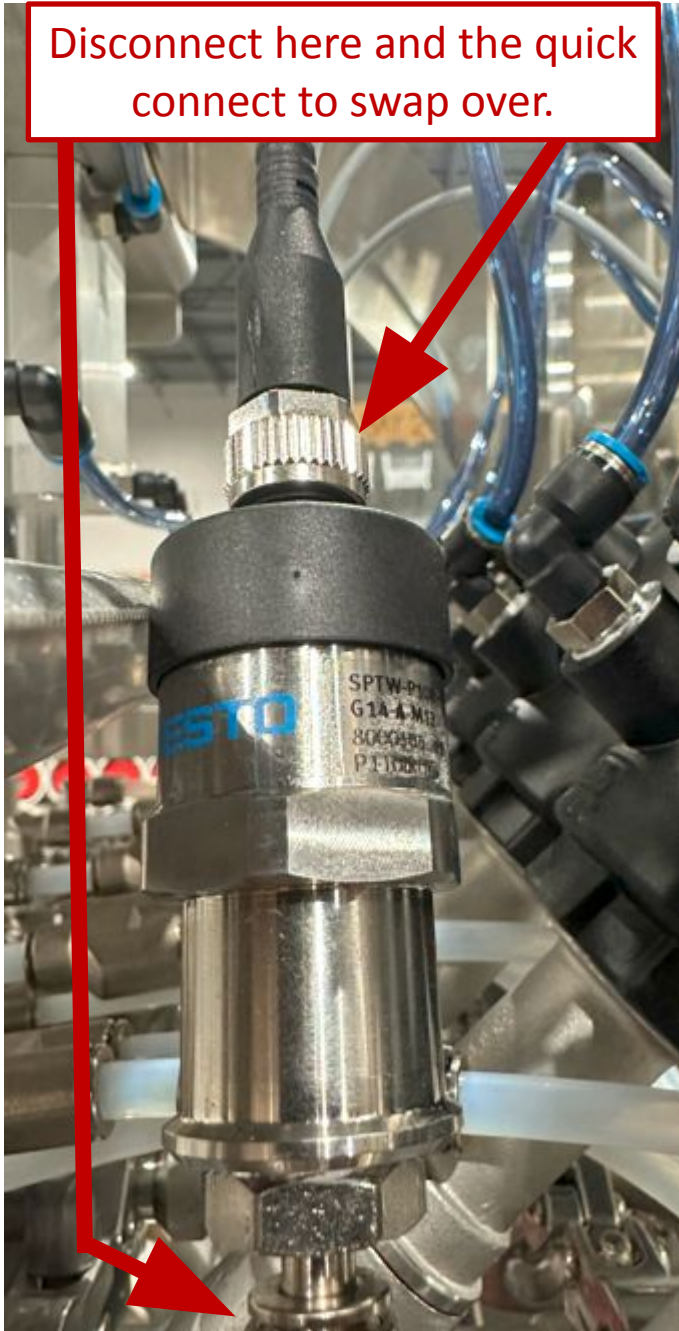
Step 1

Our first order of business is going to be to swap the “problem” transducer with the fill head next to it and see if the asterisks move to that fill head.

In the photo below, we will swap the transducer on fill head 4 with the one on fill head 5 and see if the asterisks move over to that head.

If the issue moved fill heads, you have a bad transducer and it will need to be replaced.

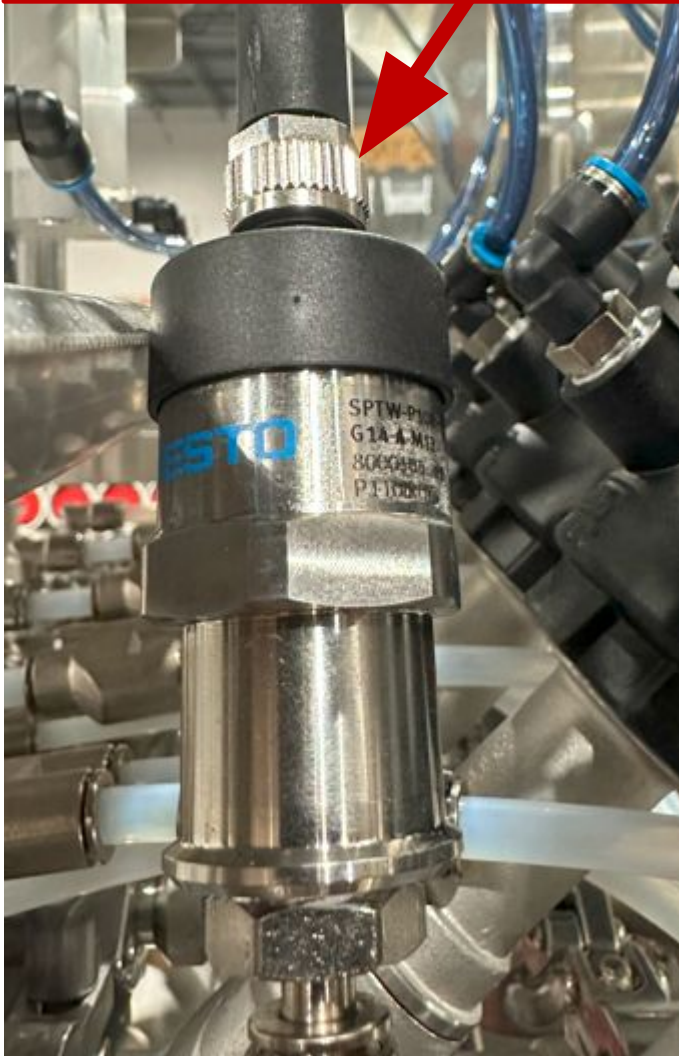
Step 2

Just disconnect here and swap over. Leave the transducer at that fill head and just swap the cables.

If there was no change by swapping the transducer itself, our next step is going to be to swap the “problem” cable with the fill head next to it and see if the asterisks move to that fill head.

In the photo below, we will swap just the cable on fill head 4 with the one on fill head 5 and see if the asterisks move over to that fill head.

By doing this, the readout for Can 5 will be the transducer on fill head 4 and Can 4 will be the readout for the transducer on fill head 5.

If the issue moved fill heads, you have a bad cable and it will need replaced.

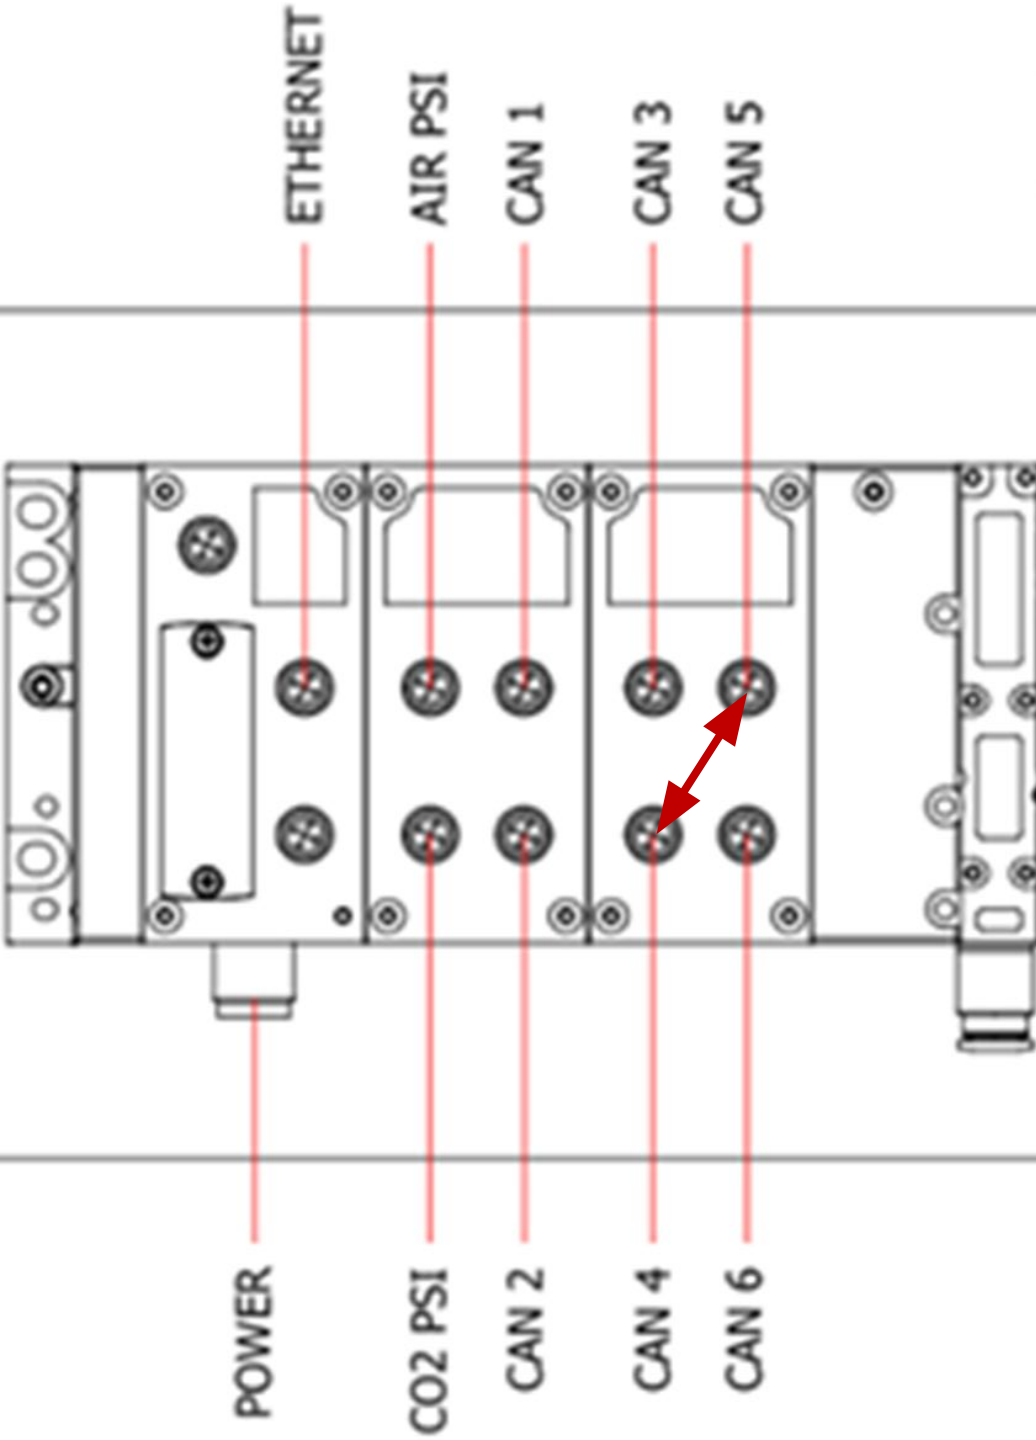
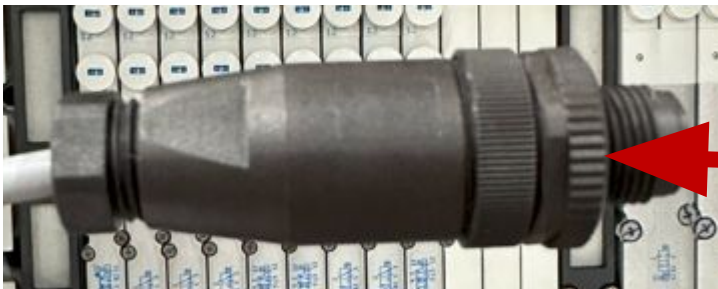
Step 3

In the photo to the left, you will see a map of the connections at the festo manifold.

If the issue is at fill head 4, unscrew the black connector from the module. Before we swap the connection of fill head 4 with the one for fill head 5, see if simply unplugging the connection changed the HMI reading for can 4. If asterisks remain, skip to step 4. If the reading goes to 0.00, swap the connection from fill head 4 with the fill head 5 connection.

Unscrew here at closest knurling to disconnect from the module.

Unscrew these 2 points to
open up the connector

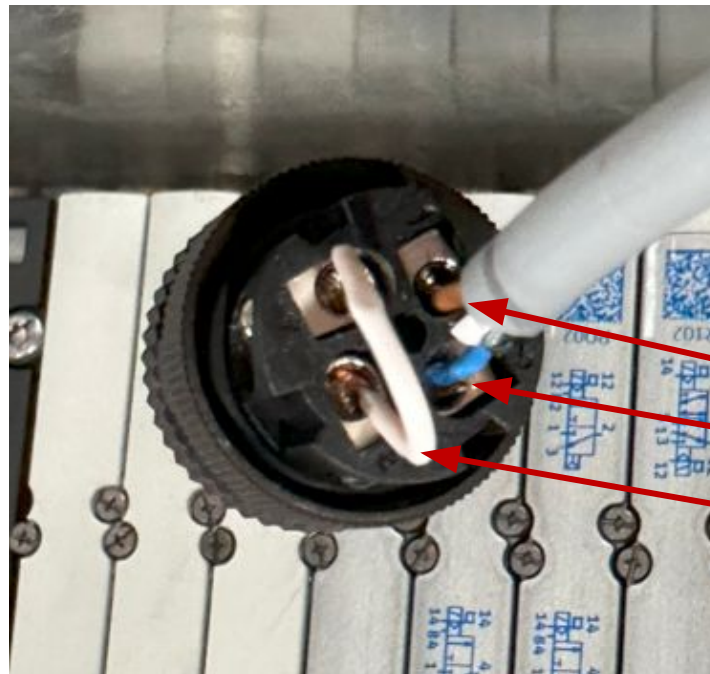
In the photo below, You can see that there is a brown and blue wire from the grey cable, as well as a jumper cable. The same needs to be accomplished whether you trim the wire back and reseat fresh, or keep the wires the same.

Connection 1 - Brown

Connection 2 - Blue

Connections 3,4 - Jumper

If reseating the wires did not resolve the issue, you will need a new connector for cable to module.

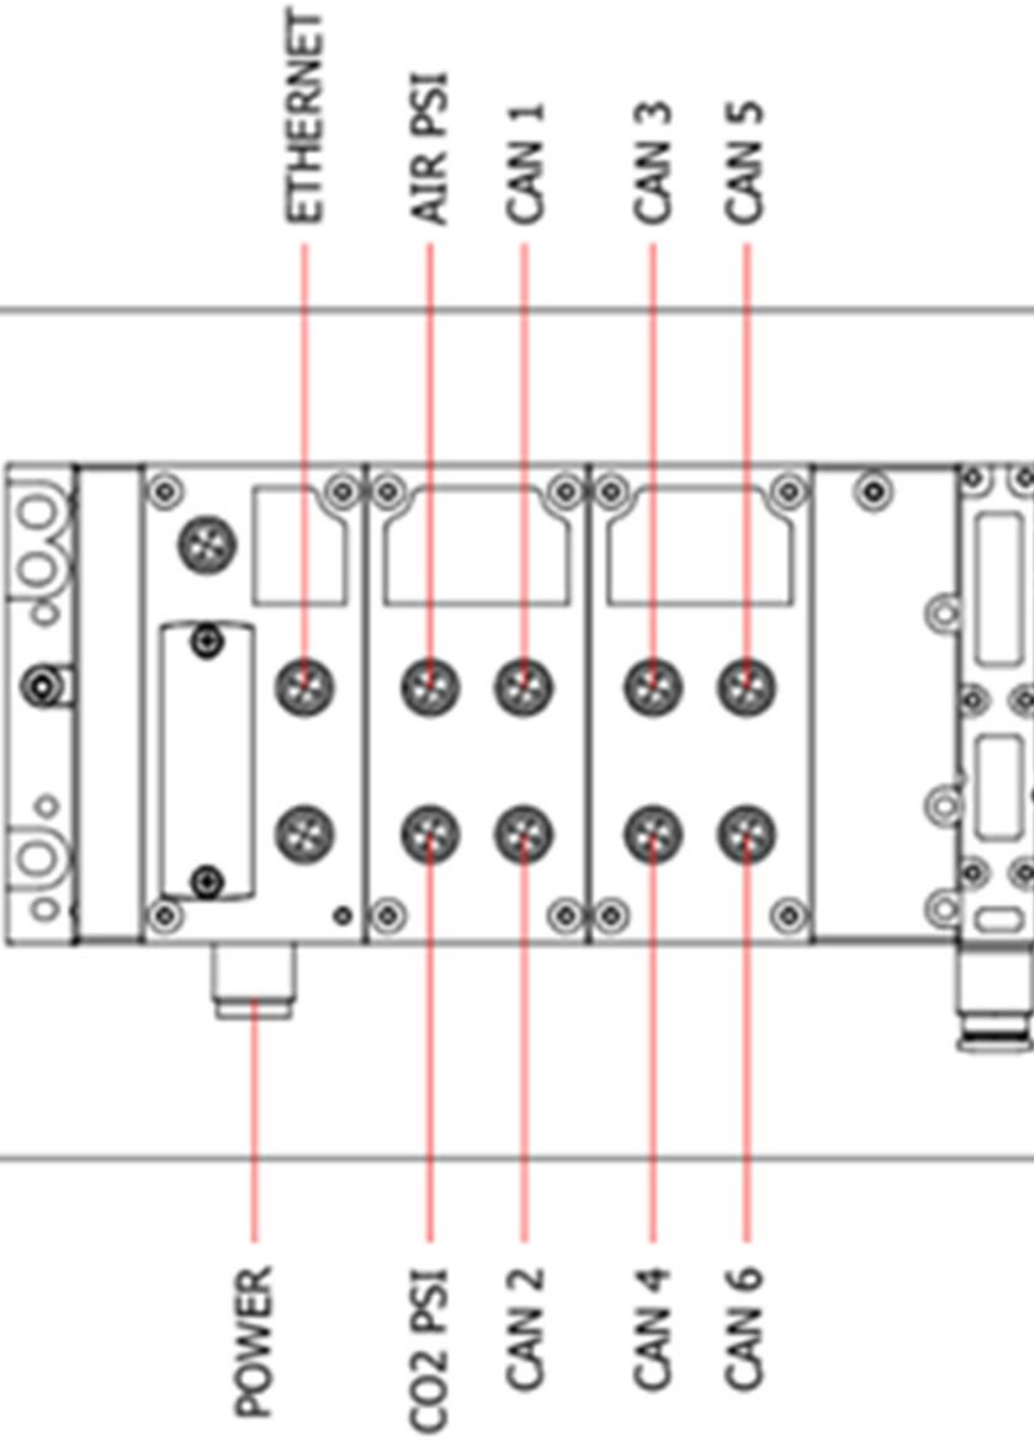
Step 4

With no change to this point, the only piece of the puzzle we haven't moved is the module block itself.

In the photo to the left, all the swapping back and forth that we have done to this point has stayed on the same block. Can 4 and 5 are sharing that same module, as well as its backing plate.

We have the choice of trying a couple earlier steps but swapping to the other block. ie: swapping the transducer on can 4 with can 2, or swapping module connections. The reason we have not done so thus far has to do with truly isolating the problem.

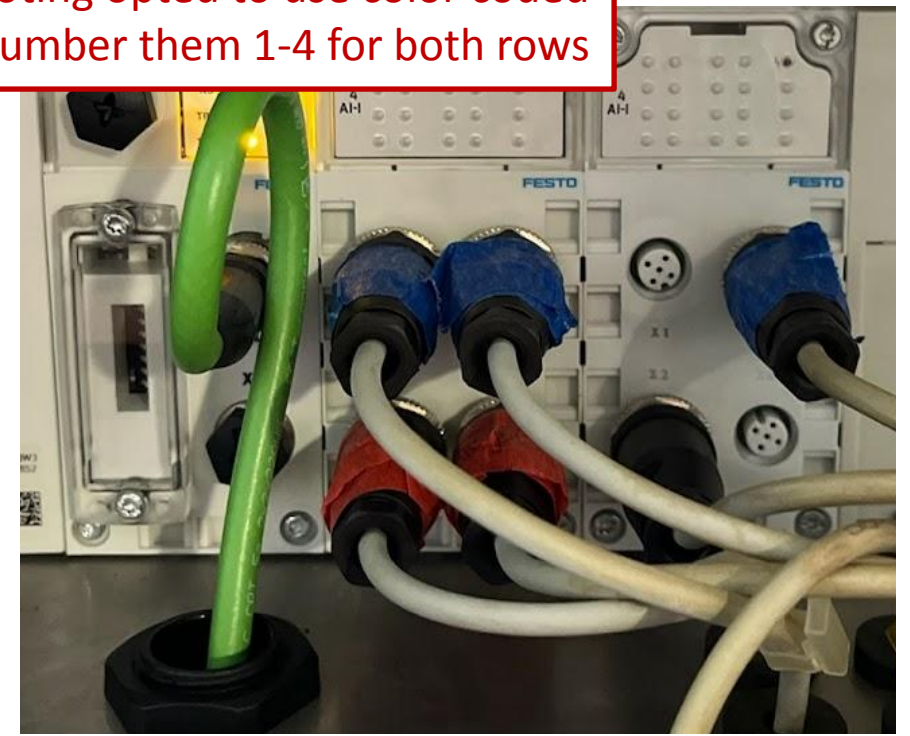
Step 4

To swap the blocks, we need to unplug all black connectors from the module. Be sure to document their locations in some way. In the photo below, a customer going through this same troubleshooting opted to use color coded tape, as well as number them 1-4 for both rows

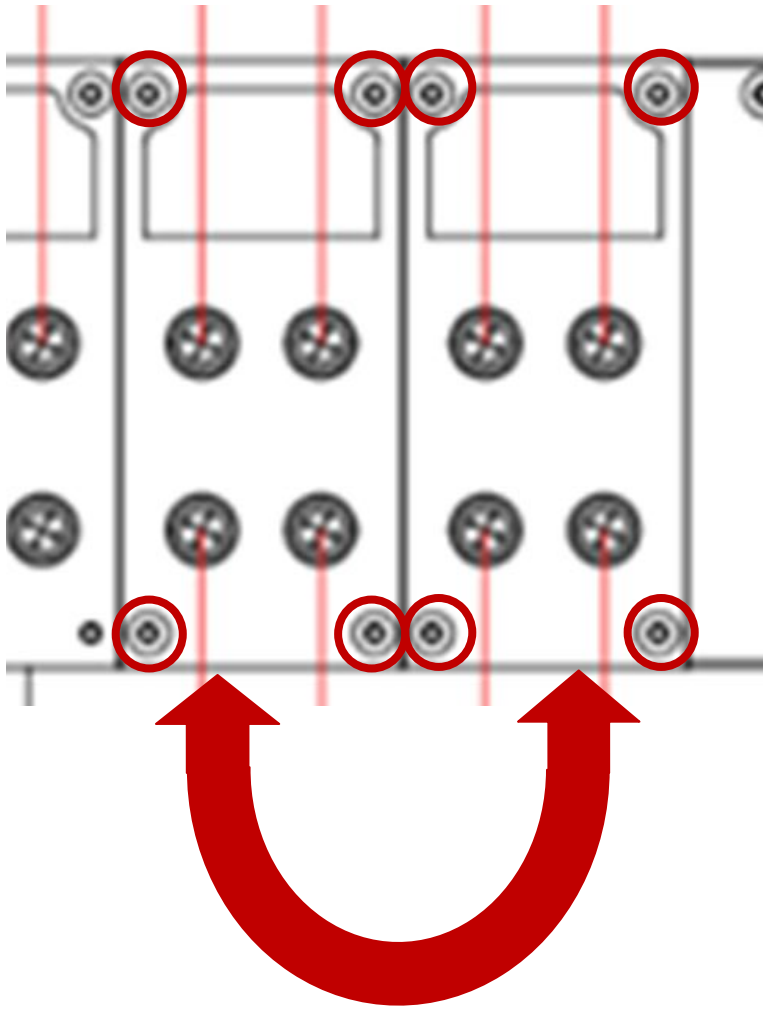
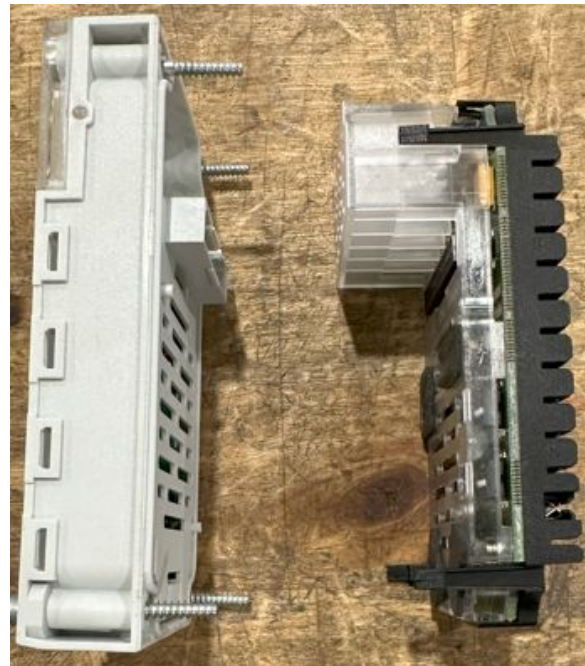
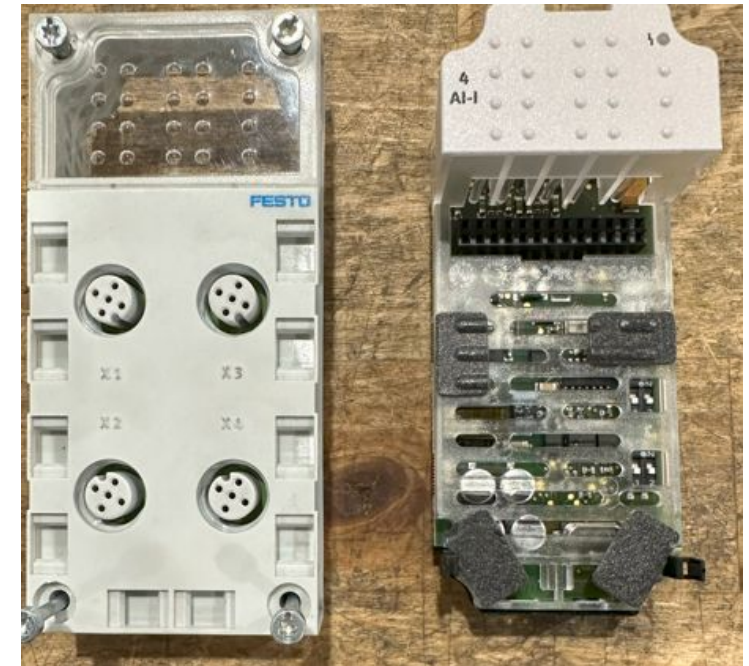
Step 4

After removing all the black connectors, it is now time to swap the blocks. You can do so by unscrewing the 4 screws at the corners of the blocks. The modules are in 2 pieces, front and back (shown below).

Because of this, we can run this test 3 times. Swapping just front plates, swapping just the back plates, and finally swapping the entire modules with each other.

For each of those 3 tests, reconnect all your black connectors in their original orientation.

If the issue moved from can 4 to the main CO2 reading during any of the swapping, then you will need a new module. Contact the Codi Service Team for exact part number needed.

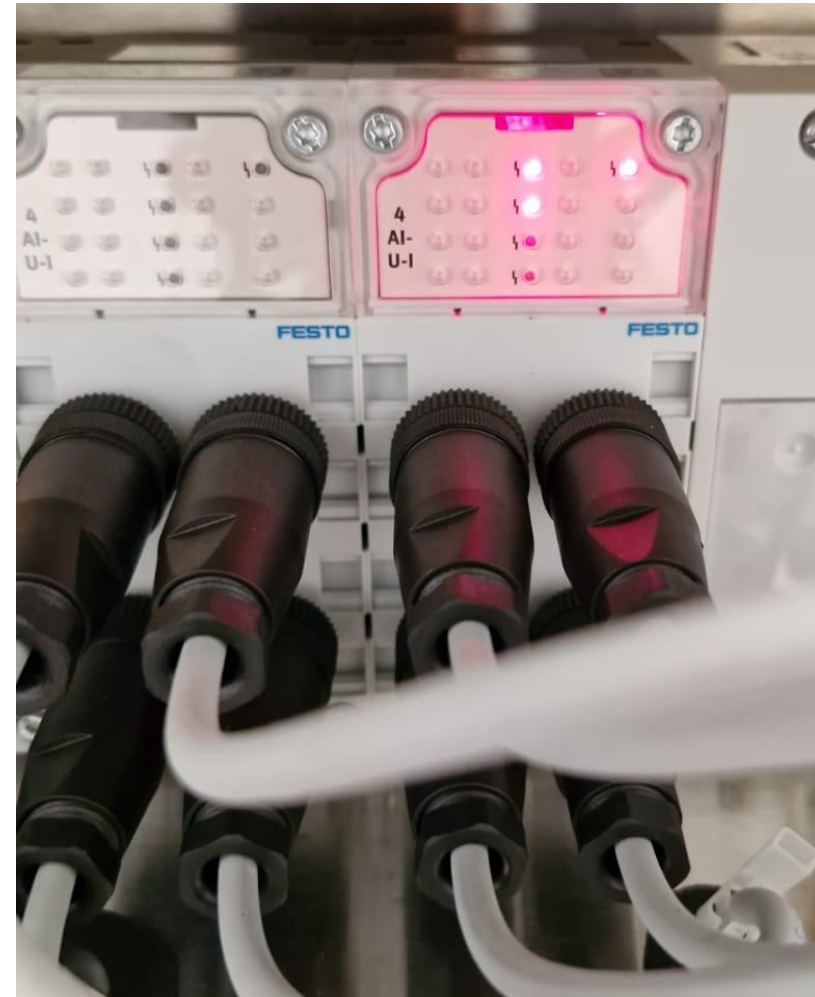
We will now walk through the steps to find the issue of red lights on a terminal block on the Festo Manifold.

When red lights are showing on the Module of the Festo Manifold, this information will correlate with the HMI's valve manifold info button.

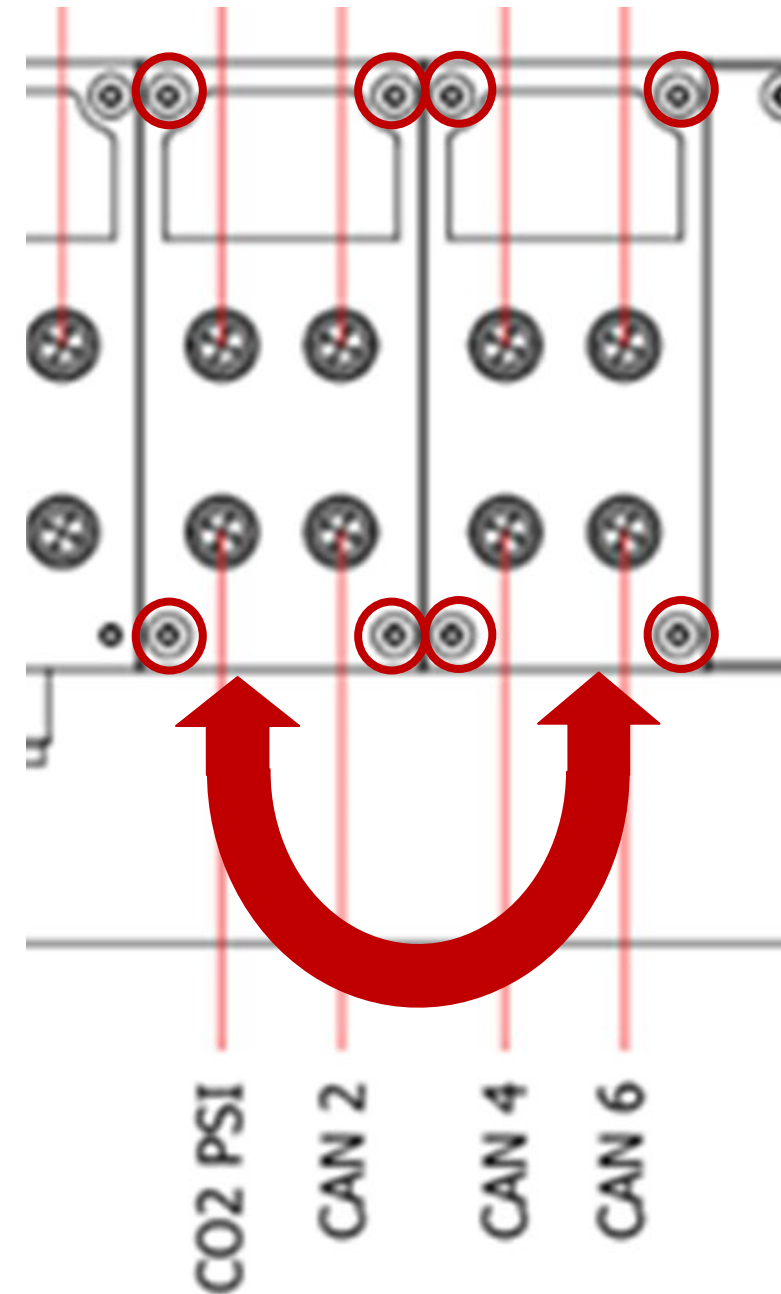
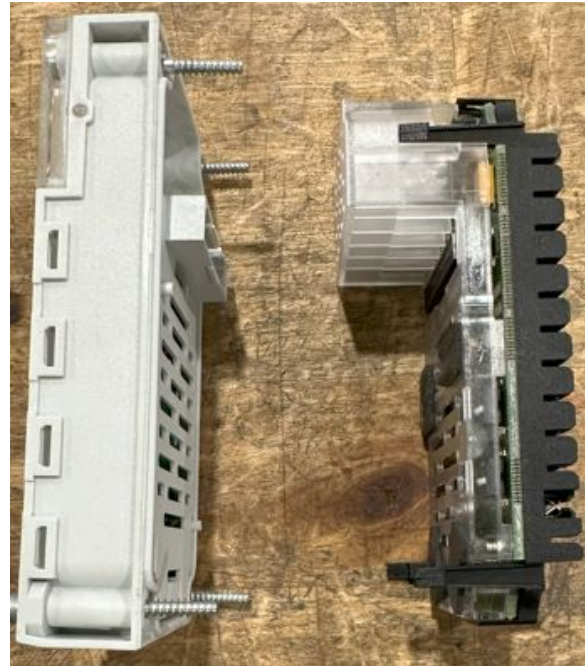
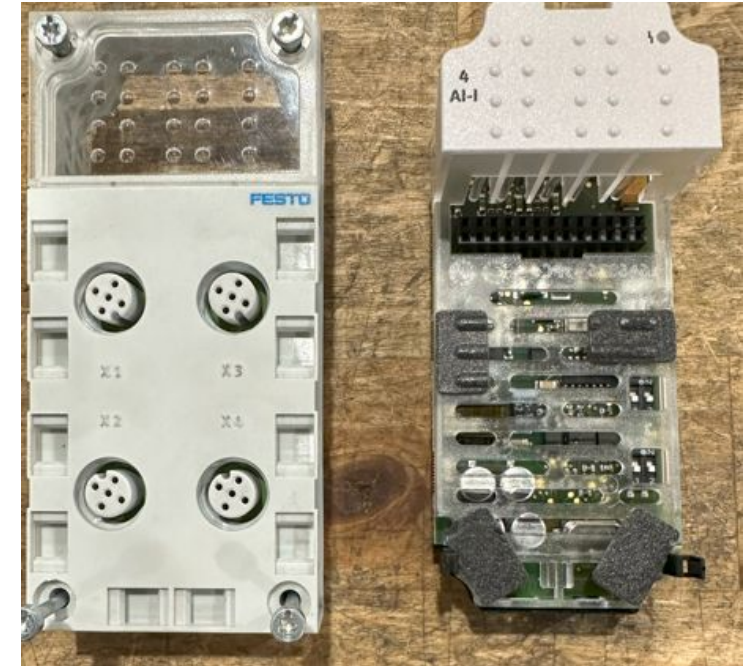
Step 2

If this brought no change to the red lights on the module block, we are going to do a physical swap of the 2 modules. Notate your black connector locations so that they plug back exactly where they were.

We can run this test 3 times. Swapping just front plates, swapping just the back plates, and finally swapping the entire modules with each other.

For each of those 3 tests, reconnect all your black connectors in their original orientation.

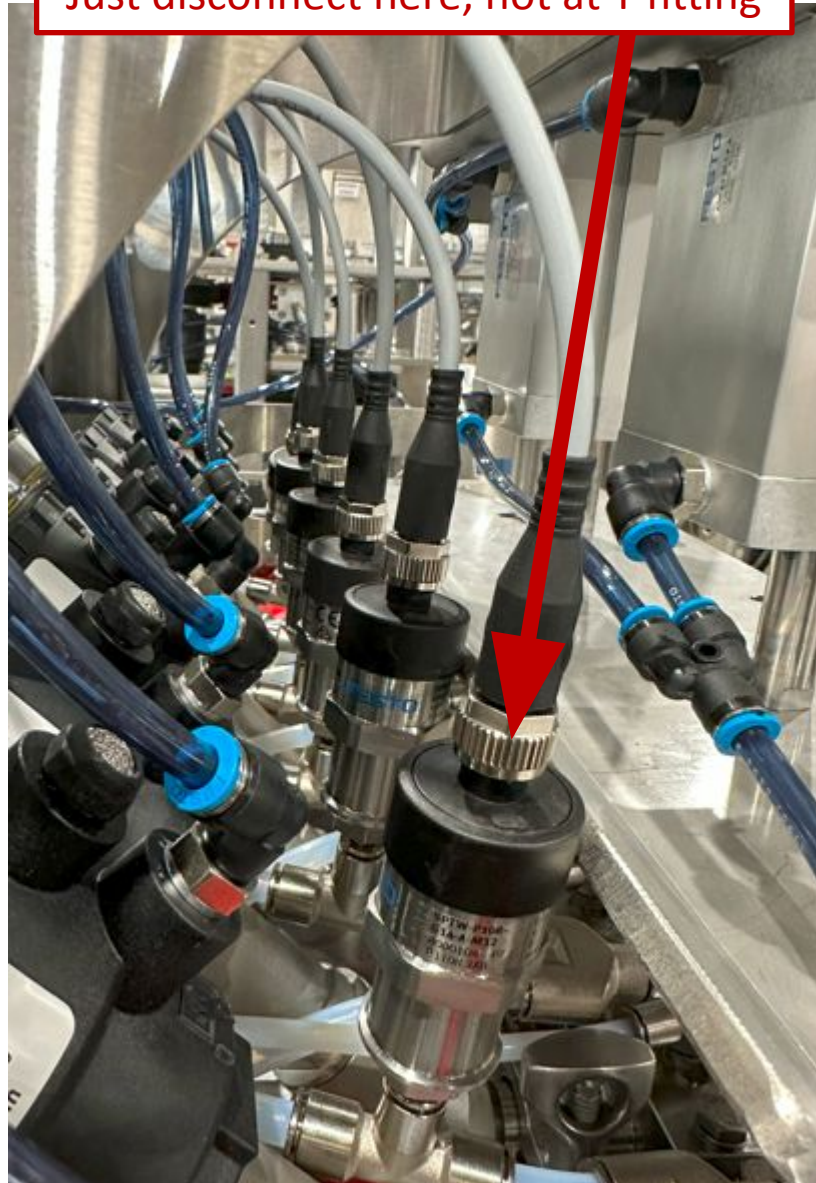
Step 3

Just disconnect here, not at T fitting

If there was no change, our next step is going to be to disconnect all the transducers on the problem module. In the photos at left and below, we will disconnect just the cable of the transducer.

Module 1: Main air, Main CO2, Cans 1 and 2

Module 2: Cans 3 - 6

After unplugging all module connections at the transducer, if the red lights stay on, proceed to next step.

If the lights go out with everything unplugged, reconnect one cable at a time to see which transducer is causing the issue.

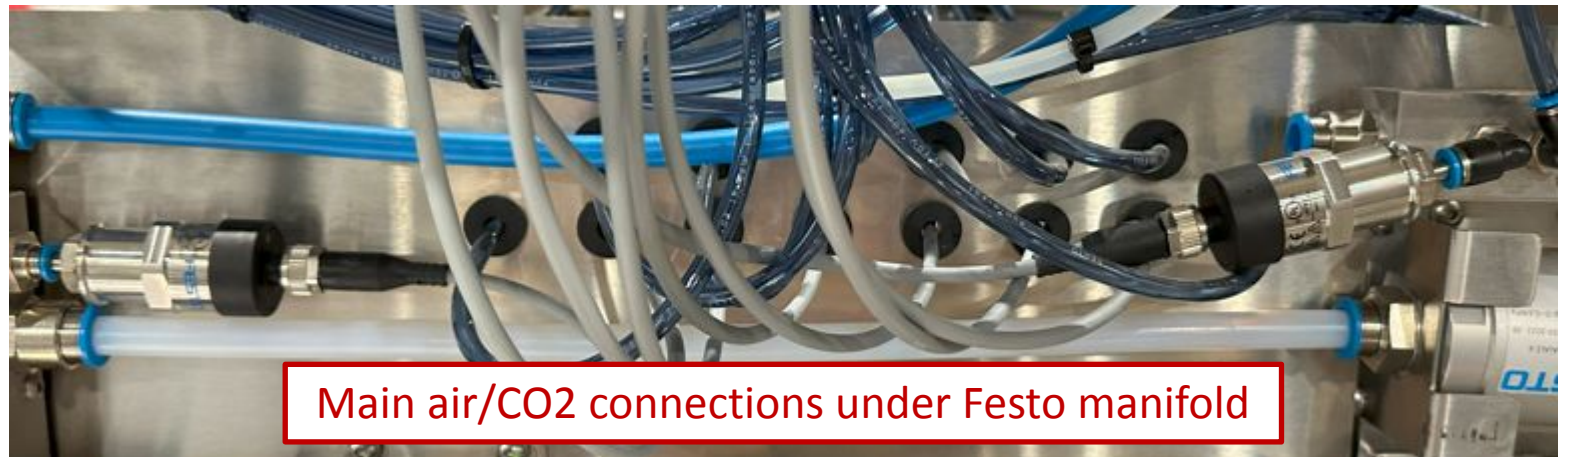
Main air/CO2 connections under Festo manifold

6 fill head connections behind carriage
